**HAL F. LEARY HOME INSPECTIONS**

**A REPORT ON THE CONDITIONS AT:**

**001 Sample Street**

**October 16, 2008**

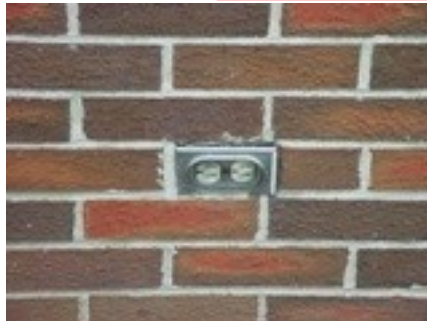
*\*The weatherproof cover is missing at the patio outlet.*

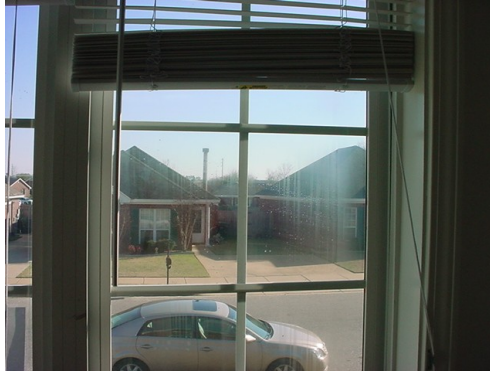
*\*The window in Bedroom #2 has lost its thermoseal, which has resulted in moisture condensing between the double panes.*

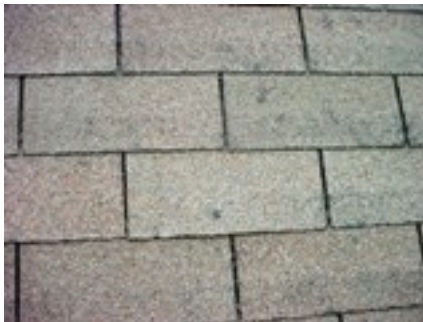
*\*The shingles are hail damaged at the rear slope. Replacement is recommended.*

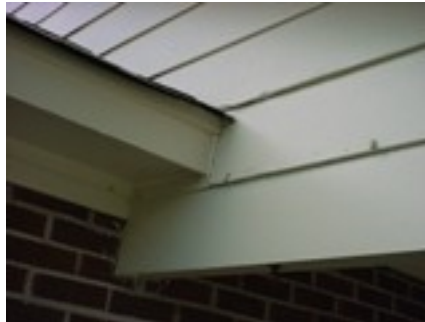
<b>Outside Faucets:</b>	<u>Acceptable</u>
<b>Brick Veneer:</b>	<u>Acceptable</u>
<b>Siding:</b> Material: "Masonite" <i>*There is minor damage at the left end of the front porch. (See photo and note at "Sidewall Flashing" on page 7.)</i>	<u>Needs Attention</u>
<b>Fascia:</b> Material: Aluminum	<u>Acceptable</u>
<b>Soffits:</b> Material: Vinyl	<u>Acceptable</u>
<b>Entry Doors:</b>	<u>Acceptable</u>

*\*The sidewall flashing terminates behind the siding at the left end of the front porch. This has resulted in moisture damage to the siding.*

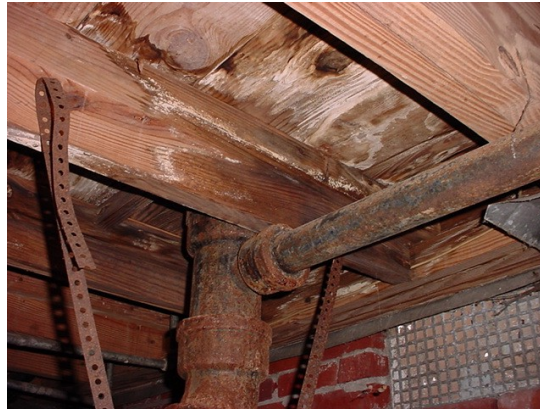
*\*There is moisture damage under bathroom #2. Moisture was detected in the sub-flooring. This is in the area below the loose toilet. Further evaluation and correction by a licensed contractor is recommended.*

**Toilet:** Needs Attention  
*\*The toilet is not securely anchored to the floor. This has resulted in moisture damage to the floor framing below. (See note and photo at page 8.)*

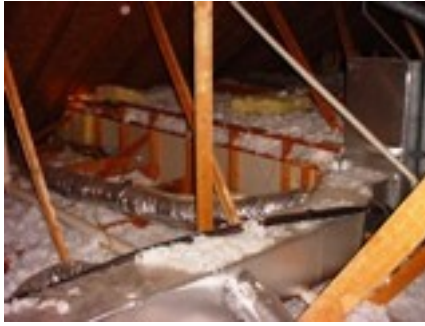
*\*Insulation is needed at the “knee wall” around the Great Room. (This is the area where the ceiling height changes from 8’ to 10’.)*

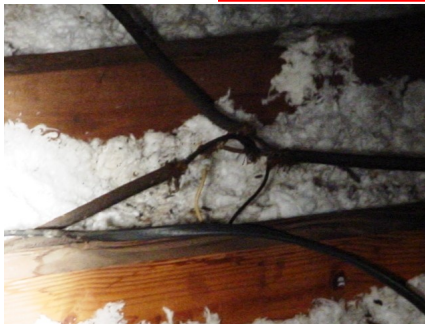
*\*There is an improper wiring junction in the attic. I recommend that it be evaluated and corrected by a licensed electrician.*

*\*There is an improper wiring junction in the attic. (See photo and note on page 9.)*

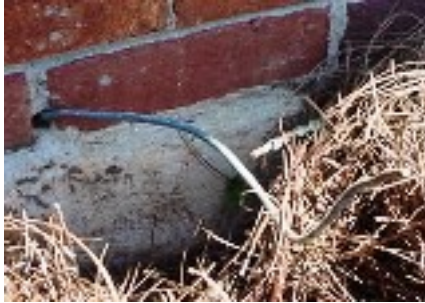
*\*The clamp is broken and the ground cable is not secured to the ground rod. This is a hazardous condition that requires immediate correction by a licensed electrician.*

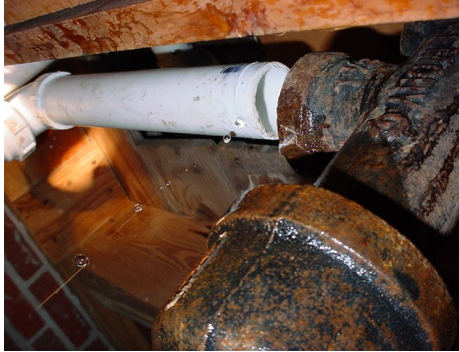
*\*The drain pipe from the sink is not connected under the Master Bathroom.*

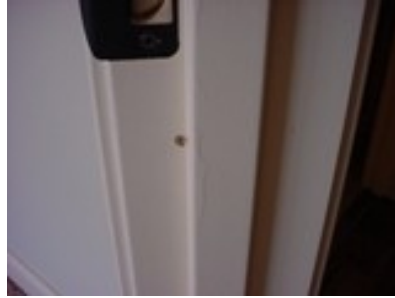
*\*Touch-up is needed at the jamb in bedroom #2. All bedroom doors should be trimmed at the bottom to clear the carpet and allow air flow under the doors when they are closed.*
